Department for Communities (DfC) - Proposed	26 th October 2016
Listing – White House Mill, Cushendun.	
PLANNING COMMITTEE	
For Decision

Second Survey Database District Council Consultation Report

Address
White House Mill
At rear of 44 Glendun Road
Cushendun
Co. Antrim
BT44 0PY

Corn & flax mills, mill races, waterwheel and machinery

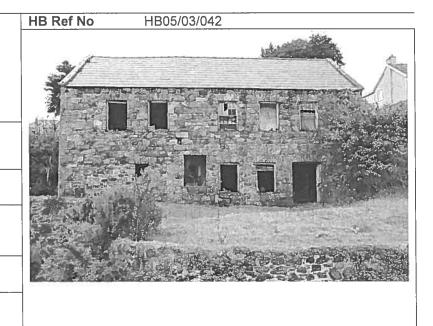
A two-storey (+ attic)/ two-bay water-powered corn mill of 1847, complete with waterwheel and milling equipment. It is abutted by a roofless single-storey/ single-bay flax scutching mill of c.1915, also containing all its machinery.
