CUSHENDALL SEA DEFENCE WALL	7 th November 2017
TO: ENVIRONMENTAL SERVICES COMMITTEE	
FOR DECISION

The purpose of this Report is to request permission to progress to Stage 2 of the Capital Programme Management System (development of detailed designs and specifications and progression of procurement process).

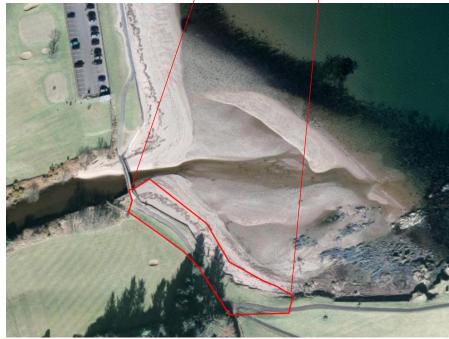
In July 2017 it was reported that a section of the existing sea defence wall at Cushendall had failed.

Officers investigated probable causes of the failure and instigated site investigation to inform potential solutions. It has been concluded that without intervention further erosion will take place impacting on public safety and amenity in the adjacent area.

Structural Failure and Scouring Evident

The preferred option has been costed as part of a feasibility review – this being a reinforced concrete wall bedded on rock and supplemented with scour protection to mitigate against future undermining of the wall.

It is also proposed to carry out remedial works to the sections of wall either side of the current failure (including adjoining the footbridge) where there is scouring evident. The costs from the feasibility study of the above solution is £200,000.00 which includes an allowance of 15% for optimism bias.

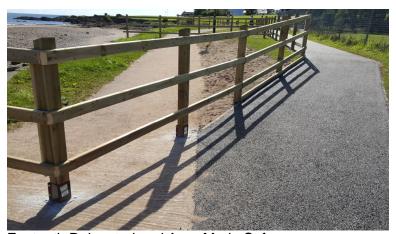
The Capital Works Department attended site and made safe by relocating the footpath and isolating the affected area.

Footpath Relocated and Area Made Safe
