| <b>Ballysally Youth &amp; Community Centre SOC</b> | <b>14<sup>th</sup> November 2017</b> |

**The purpose of this report is to present a Strategic Outline Case in relation to Ballysally Youth & Community Centre.**

**Re: Inspection and Condition Survey of Ballysally Community Centre**

**SCHEDULE OF CONDITION**

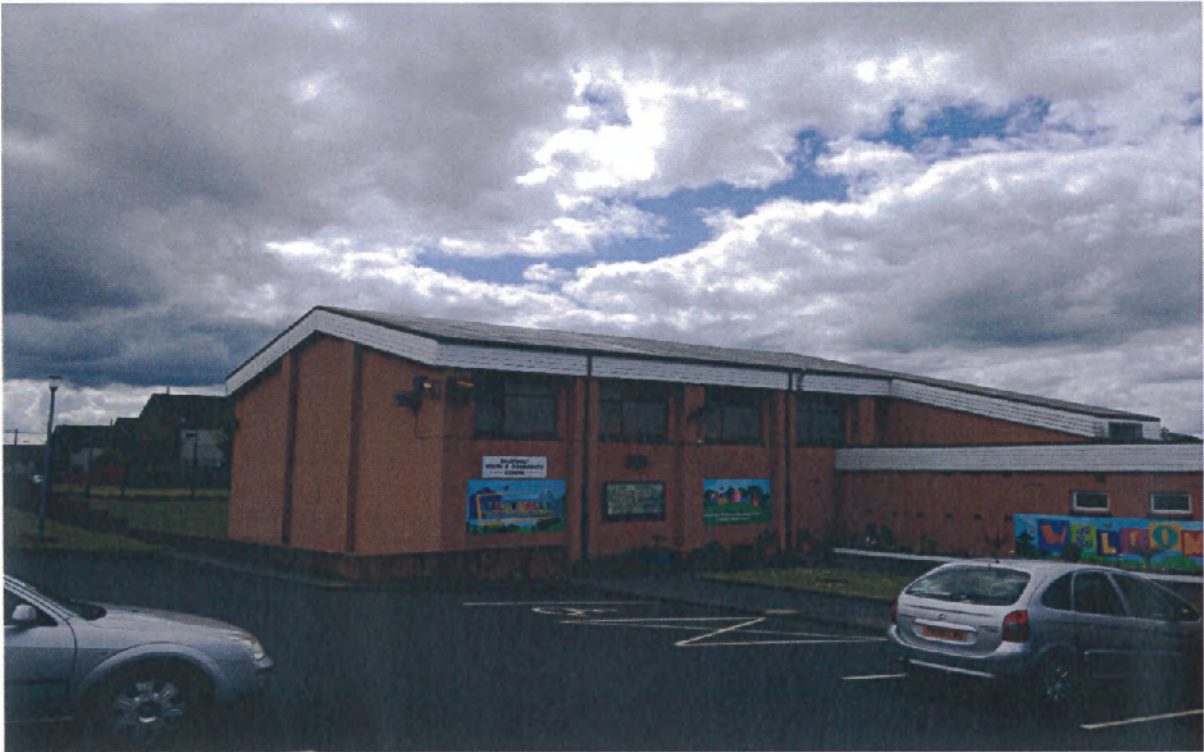
Photo 1

The majority of the building has a flat roof drainage to internal downpipes. The exception to this is the roof of the sports hall/boiler (duo pitch, monopitch respectively), draining to an external gutter (photograph 1 and 2).

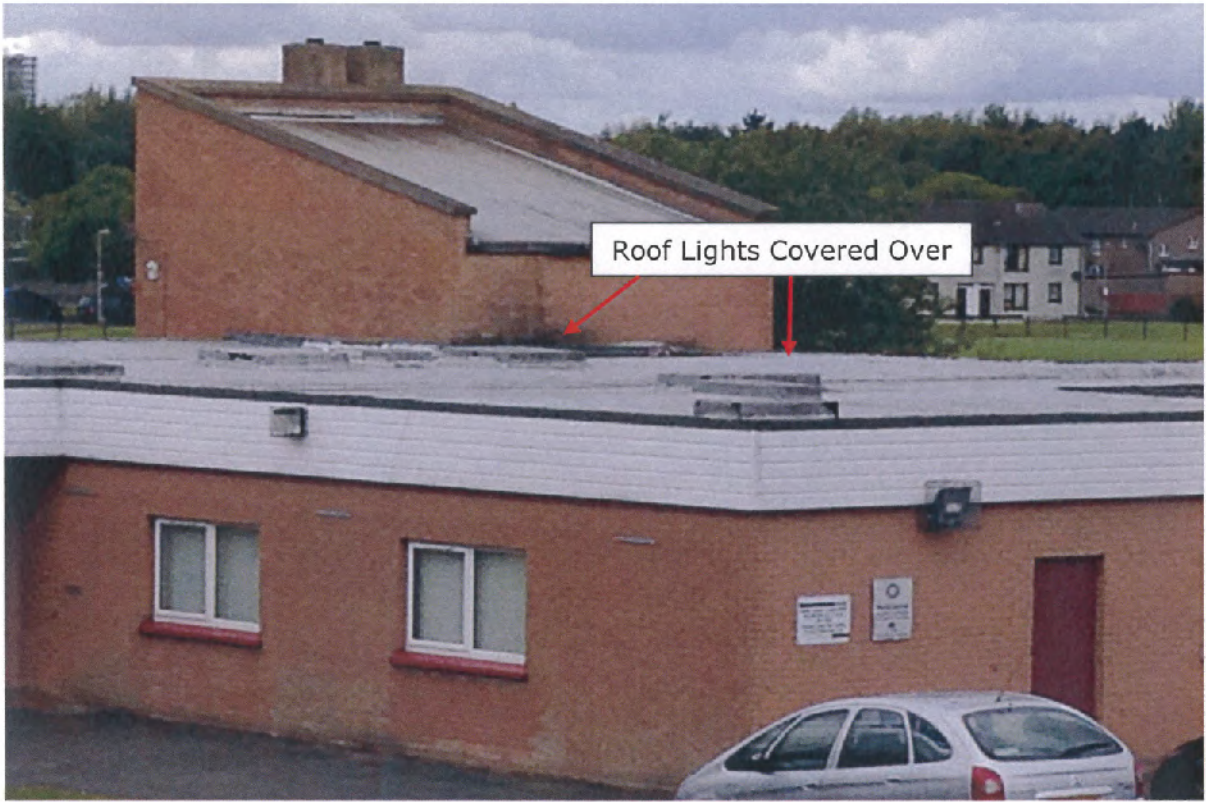
Photo 3

Roof coverings appear to be of the membrane type generally although a small section of roof to the front right hand corner is mineral felt. Considerable ponding of water was noted on the mineral felt roof. Elsewhere a number of roof light upstands appear to have been made redundant by covering over in membrane (photograph 3).

No structural issues were noted during the inspection. The ponding on the roof should be addressed before it causes problems.

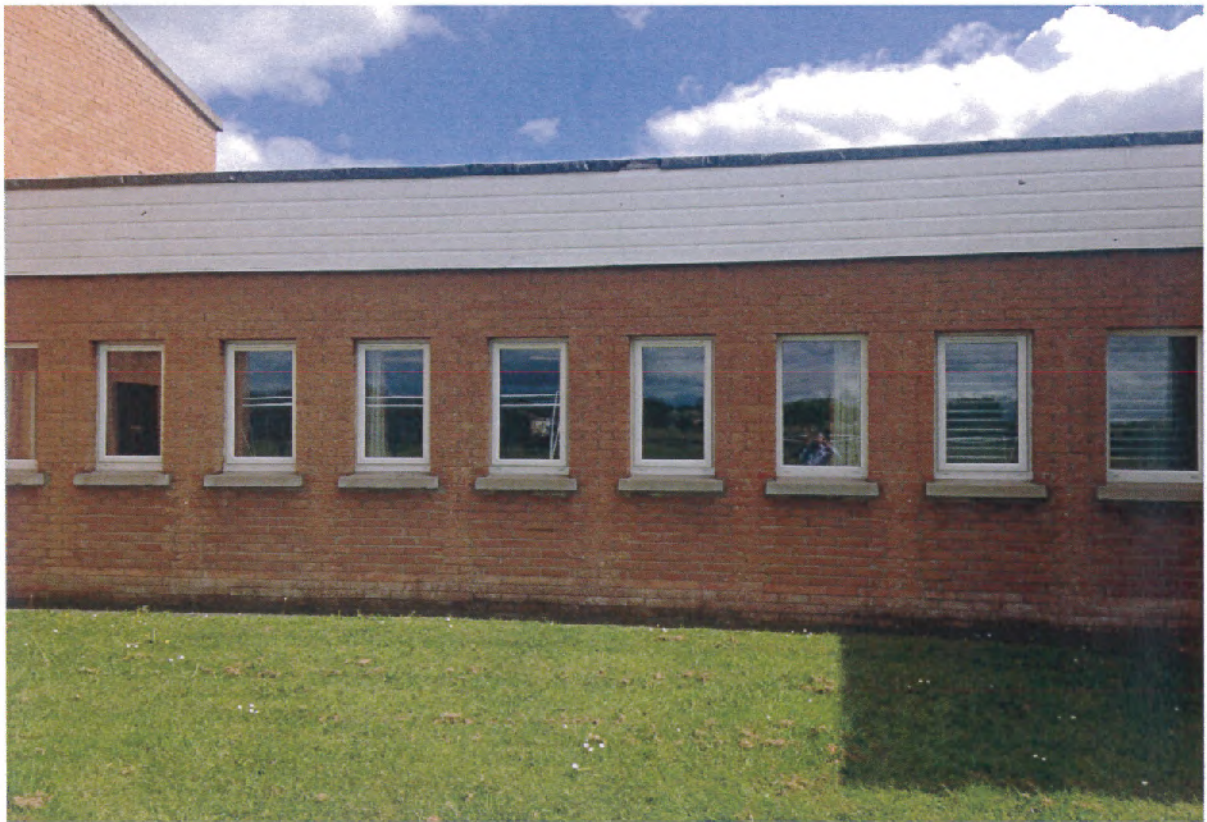
Photo 4

The external walls are clay brick with movement joints located throughout. Window heads are galvanised steel lintels, painted in some locations, with concrete window cills (photograph 4).

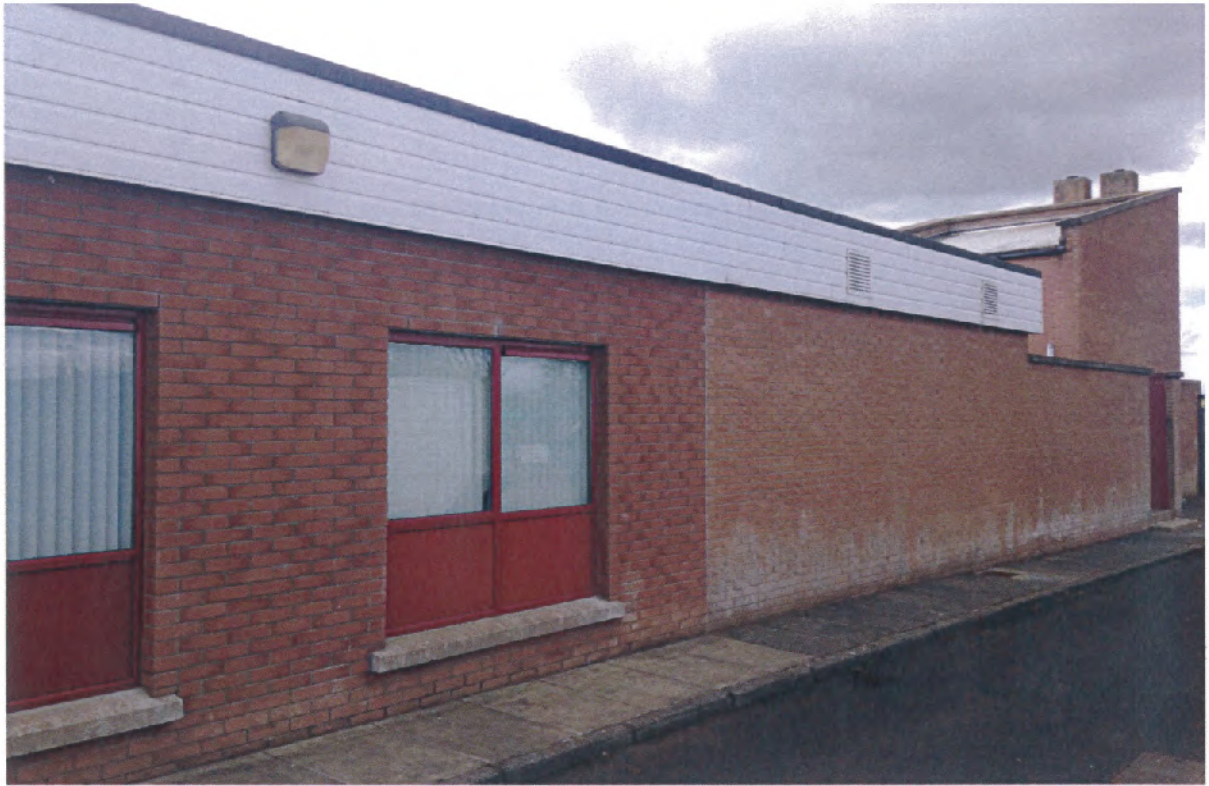
Photo 5

A deep uPVC fascia has been used around much of the perimeter of the building with a narrow timber soffit (photograph 5).

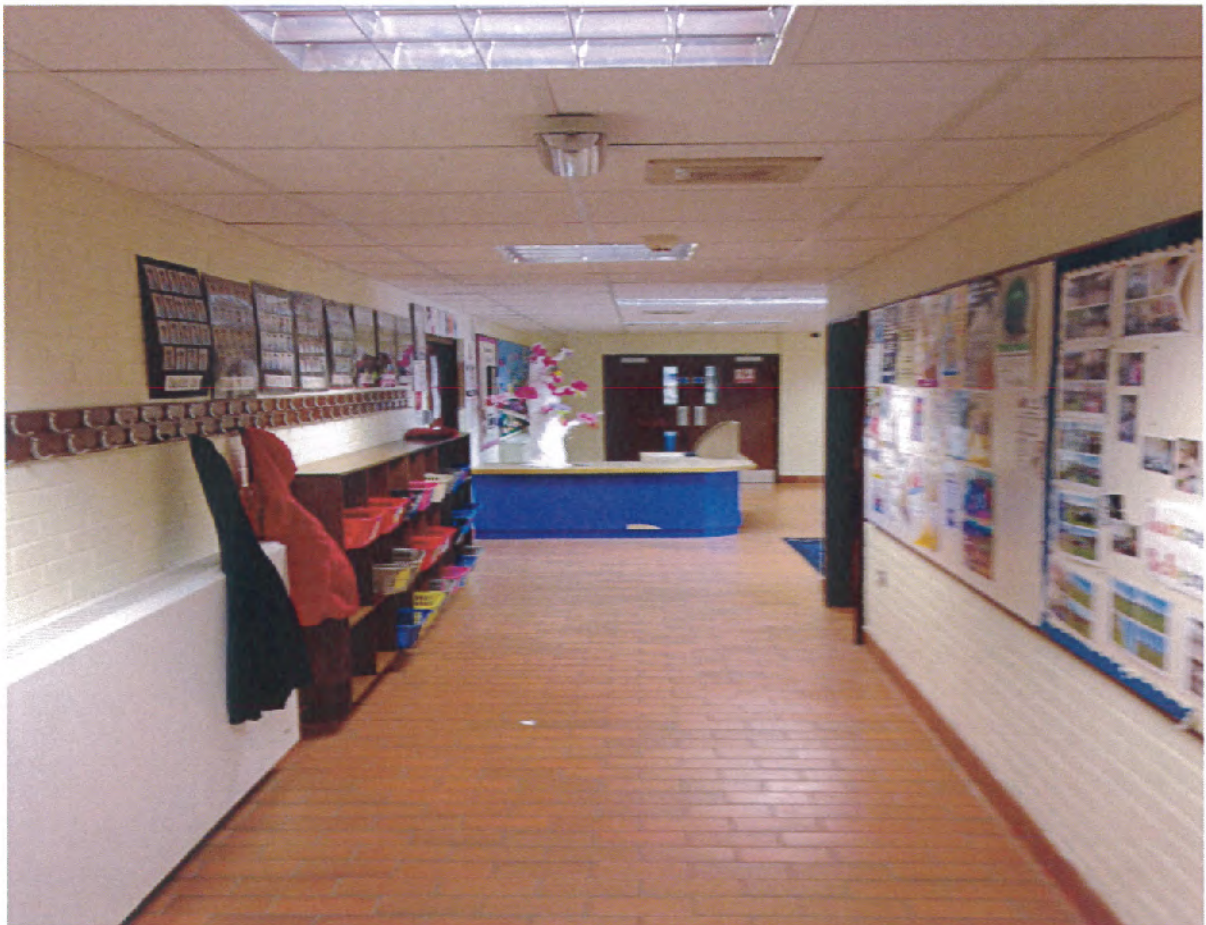
Photo 6

Internally, walls are a combination of painted brickwork (original) and smooth plaster (extensions) (photograph 6).

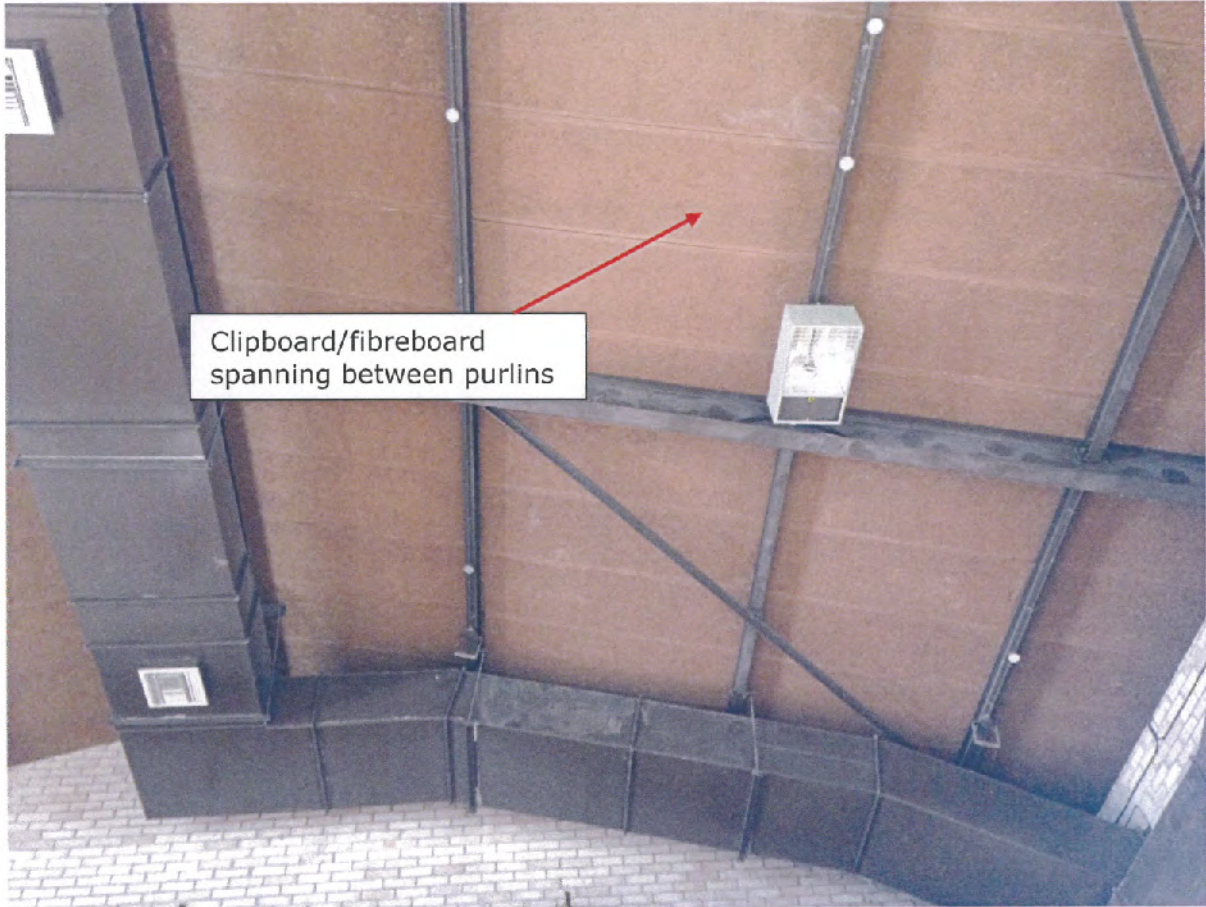
Photo 7

Ceilings are generally of the suspended variety, with more modern modules and materials used in the recent extensions. The ceiling over the sports hall is an exposed chipboard/ fibreboard type panel, spanning from steel purlin to steel purlin (photograph 7).

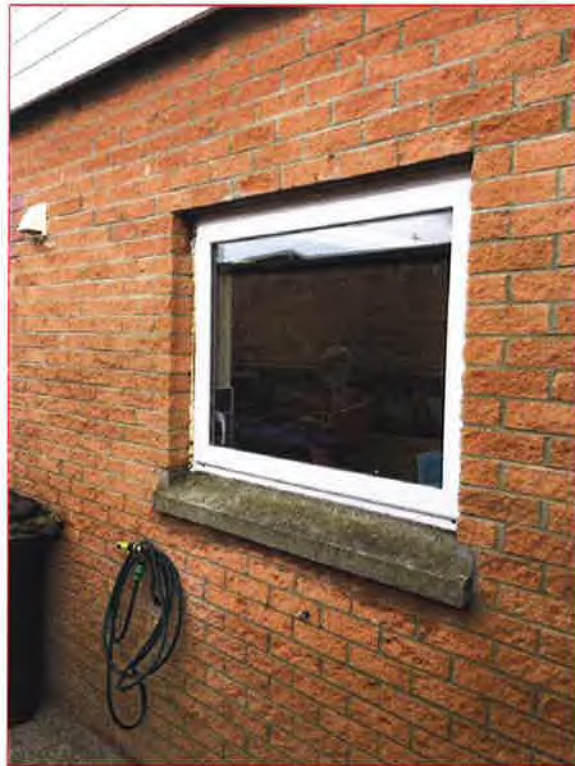
Photo 67

| ITEM | ELEMENT | SUB ELEMENT | CONDITION |
|---|---|---|---|
| 2.1.27 | Windows | PVC Double Glazed Windows | Good condition.<br><br>Photo 67 |

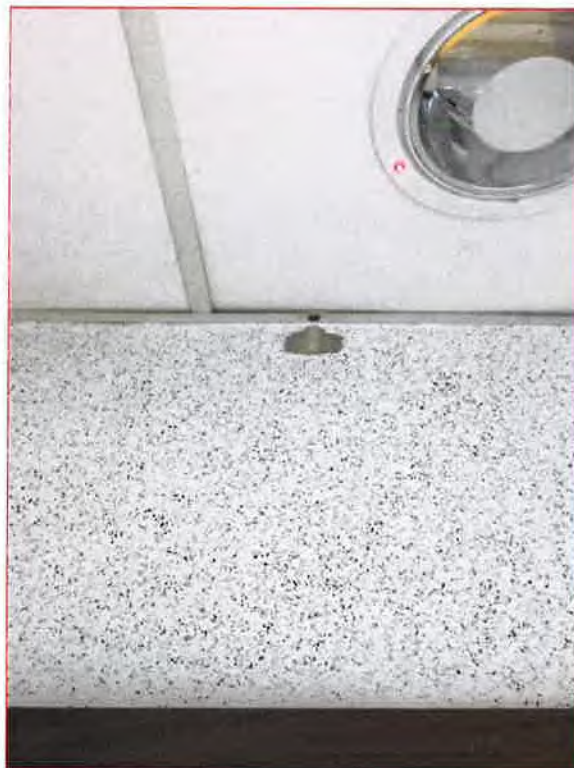
Photo 68

| ITEM | ELEMENT | SUB ELEMENT | CONDITION |
|---|---|---|--|
| 2.2.5 | Ceilings | Suspended Grid & Tile | Generally fair condition. Some staining noted. <div data-bbox="922 1301 1174 1489" data-label="Image"> </div> <div data-bbox="1177 1368 1212 1498" data-label="Caption"> <p>Photo 68</p> </div> |
